TECHNICAL BULLETIN

SUBJECT: Modified Sea-Doo PWC Unable to Achieve Expected Top Speed

MODELS: 2022+ Sea-Doo PWC with 1630cc Engine

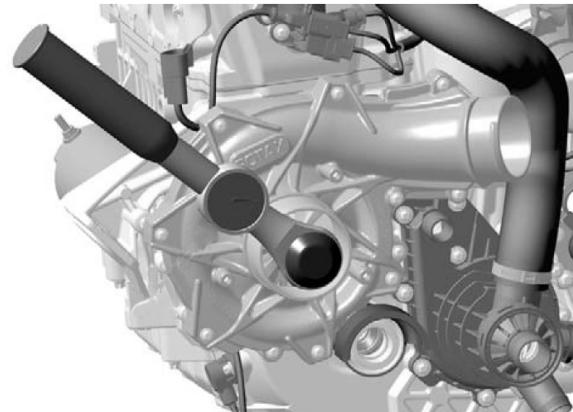
4) **Supercharger:** Supercharger slip moment must be adjusted to our recommended torque setting for optimal performance. The slip moment setting directly affects the boost performance of your supercharger.

Slip Moment for STOCK Supercharger	15 lbf•ft
Slip Moment for MODIFIED Supercharger	17~18 lbf•ft
Locking Nut (Clutch Side)	24 lbf•ft
Impeller Nut	22 lbf•ft

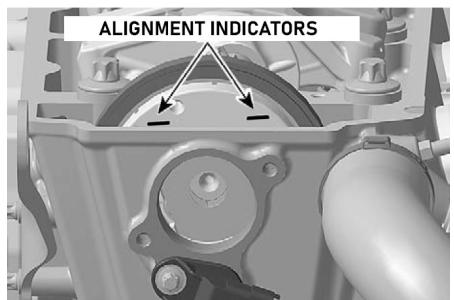
6) **Compression:** Compression should be 150psi ideally. Higher compression (>5psi) is a sign the Camshaft Gear is not aligned properly and should be checked.

7) **Cam Gear Position:** Verify cam gear is secure not out of position. Alignment marks should favor exhaust side over intake side. Advancing or retarding further can result in loss of top speed. See reference image. →

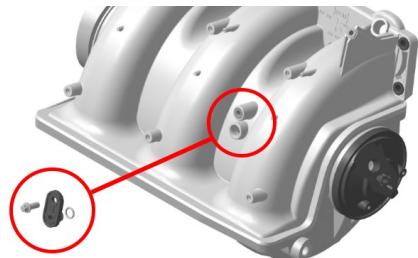
- If you chose to utilize the “blank” plastic cover on the intake manifold for a vacuum port fitting, check to make sure it is not cracked and that the O-ring is not dislodged or missing. We recommend a billet aluminum replacement designed to reliably accept vacuum line fittings. [RS12050-VPA](#)

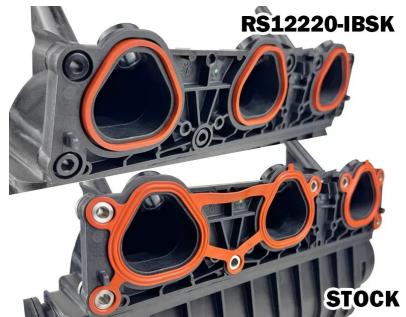
- 325hp models exhibit a common boost leak due to the inconsistent length of original bushings and thinner gaskets that can trigger a P2282 fault code. We offer a kit with precision machined bushings and broader individual seals that ensure even clamping and improved sealing on stock and modified craft. [RS12220-IBSK](#)

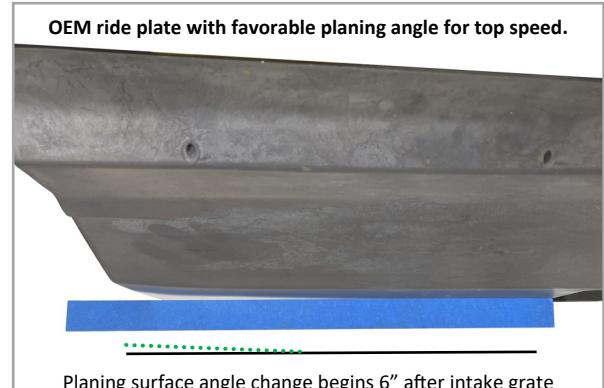
Fast Ride Plate Identification (No Top Speed Loss)

On ride plates with a favorable planing surface for top speed, the change in planing surface angle begins approximately 6 inches after the intake grate mounting point, progressively rising until the end of the ride plate. This contributes to dynamic lift enabling the bow to rise for reducing drag and allowing top speed gains on modified craft.

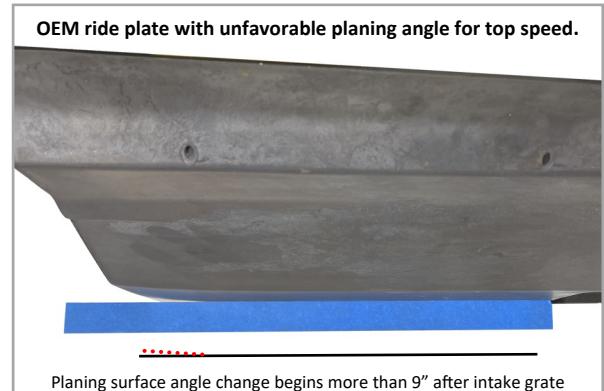
Slow Ride Plate Identification (Reduced Top Speed)

11) **Ride Plate:** Through extensive testing we have determined there is a manufacturing variance between OEM ride plates on 2022 & newer Sea-Doo watercraft that can inhibit top speed gains on affected units. This variance is not a manufacturing defect as the watercraft reach factory specified performance levels and only exhibit reduced speed gains when modified.

On ride plates with an unfavorable planing surface for top speed, the change in planing surface angle begins further back after the intake grate mounting point (7 inches or more) resulting in less dynamic lift. This causes additional drag that prevents modified craft from achieving expected top speed gains.

By modifying affected ride plates to match the more favorable specification, we are able to achieve expected top speeds on modified craft. Gains of up to 5+ MPH are common with this modification to affected ride plates.

RIVA Racing offers an 'OEM Sea-Doo Ride Plate Modification Service' (Part#: [RSS21120-RPM](#)) for 2022+ Sea-Doo models with 1630cc engine. The service involves machining your affected ride plate to the faster specification utilizing an accurate and repeatable process.
